A Critical Re-evaluation of the Usage by Disabled Groups of the Church Lammas Demonstration Project

Project Reference MA/6/1/009

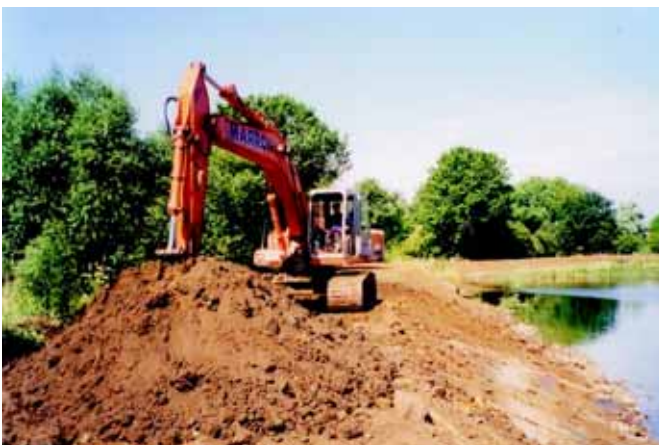
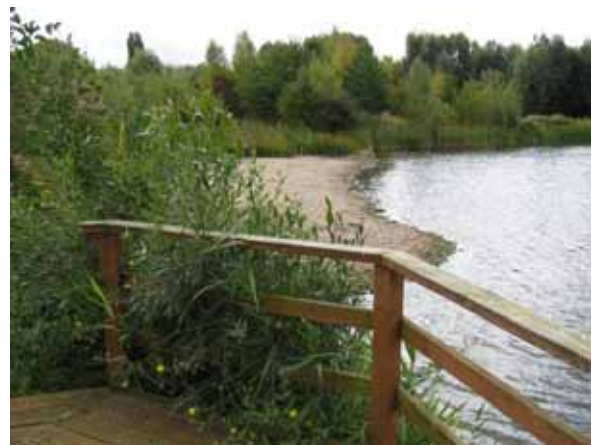
Original restoration works shown to the left of a view taken from a similar location in the Autumn of 2007

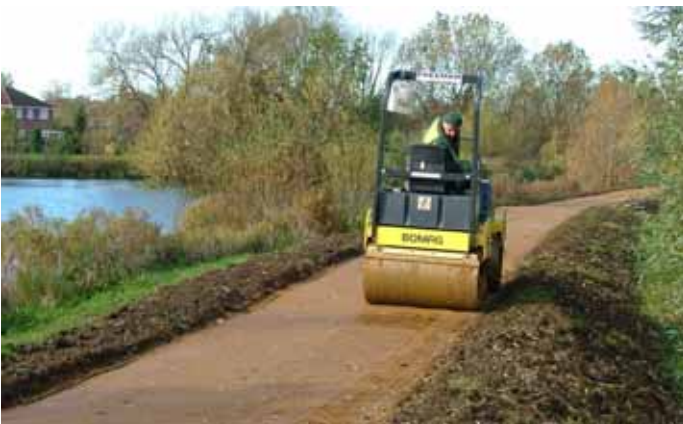
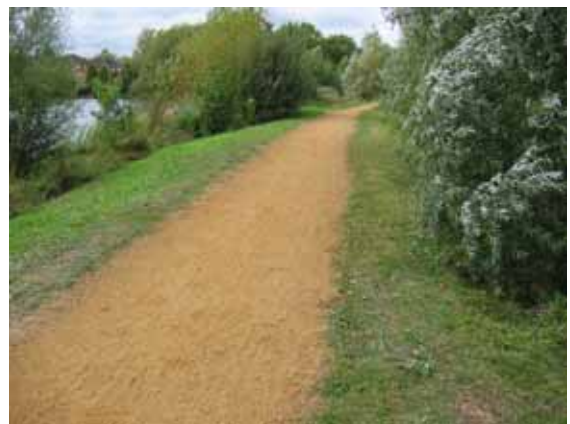
Improved footpath under construction in 2004 and a recent view taken in 2007

- 5.4 The widened paths, finished with a sympathetic rolled surface, have stood up well to use and weather, and have required very little repair or maintenance. They have been tested by wheelchair users and others, and have proved accessible throughout.

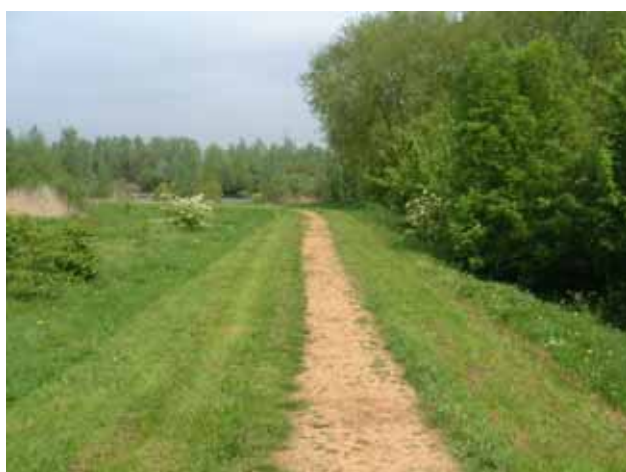
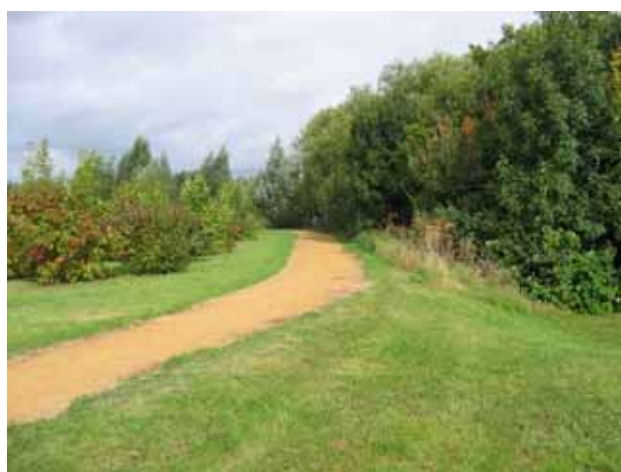
An original footpath shown to the left in 2004 and a view taken in 2007 of the same path having since been improved and regularly maintained.

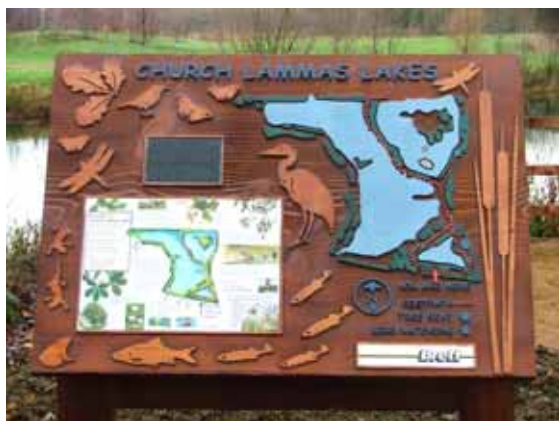
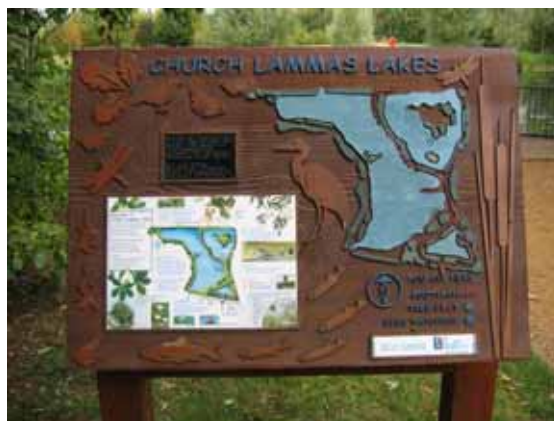
The information sign at the time of installation to the left and in late 2007

Internal Signage: the new information sign just inside the entrance was a major element of the original scheme, designed to convey the content and character of the site to all, and it was endorsed by a blind member of SCAN as “impressive” during a familiarisation visit in 2005. It had already suffered from some racist graffiti and physical damage soon after installation (the latter caused by someone attempting to scratch out the former), but this was removed and the paint touched up within a short time. No new instances of damage have occurred, although paint and wood stain colours have weathered a little in the ensuing two years. The warning and information signs at the gate are as before, and remain in good condition.

Signage: as noted above, some minor retouching of the information sign near the entrance would freshen up its appearance. No other work to information or warning signs has so far been necessary.

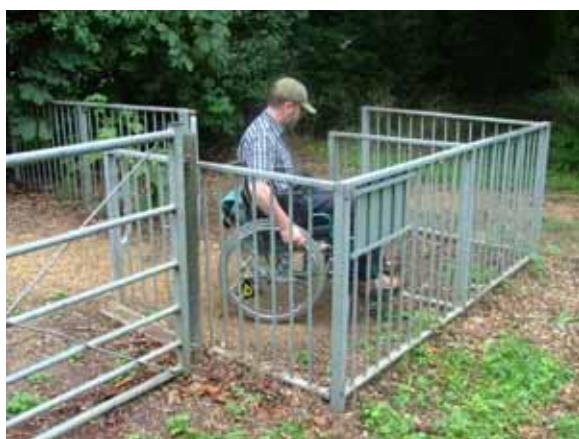
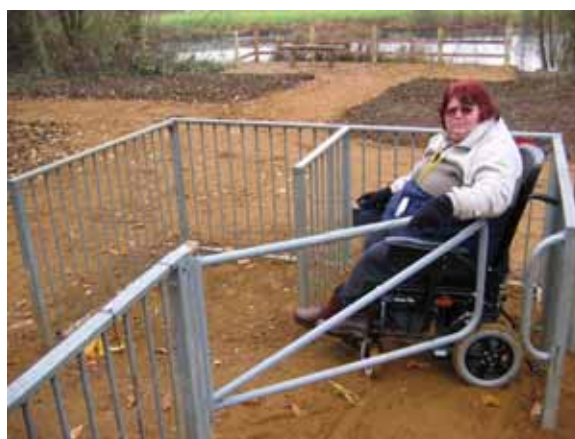
Gates: the main access gate had originally been configured as a kissing gate, to deter horse riders and motorcyclists, but although just allowing a standard wheelchair through, it was not

The original kissing gate proved adequate for wheelchair access but unsuitable for use by powered chairs

large enough for the increasingly common powered chairs, and difficult for some of the larger pushchairs. As part of the 2005 scheme, the railed enclosure was lengthened and other gates re-hung to allow easier access for pedestrians and maintenance vehicles, and to provide a RADAR lock on an existing access gate, for those not able to negotiate the kissing gate. If further developments take place on the site in the future (such as a classroom /shelter for community use) these access improvements will already be in place. The gates are still functioning as intended, although the RADAR lock mechanism is not engaging properly and needs some attention. This gate is temporarily chained shut until repairs can be effected. Some minor touching-up to paintwork would also be beneficial.

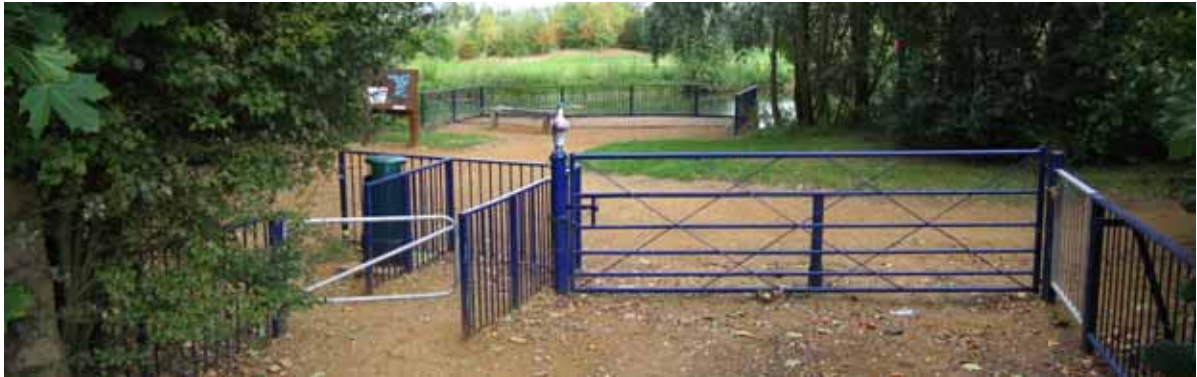
Improved access arrangements, October 2007

Gates and Gateposts: as noted above, one of the decorative gatepost finials has been stolen, and there has been minor wear to paintwork on the operating parts of the kissing gate. The original two-part epoxy paint finish was in known RAL colours, and re-touching can easily be carried out as required. A decision on replacing the missing mallard duck finial has yet to be made. Keys to the temporary gate padlock are held by Brett staff, and the repair or replacement of the malfunctioning RADAR lock is in progress.

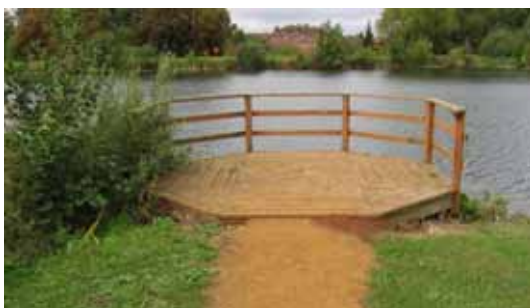
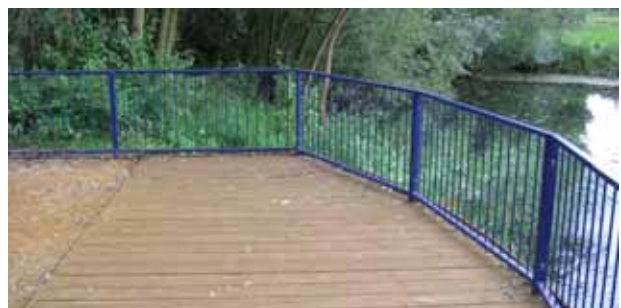
Viewing Platforms: these are still in good condition, although the woodstain finish on the smaller hexagonal one is now weathered and could be renewed to advantage. This structure is a favourite place for seagulls, which has led to soiling of the handrails. The larger viewing terrace overlooking Ashby Pond remains as constructed, with no apparent signs of damage.

Recent photographs of the viewing platforms, Autumn 2007

Viewing Platforms (Surfaces / Barriers): these remain structurally sound, and fulfill their original purpose of allowing safe access to the water's edge. Some re-coating of timber components would help to prolong life, and give a cared-for appearance.

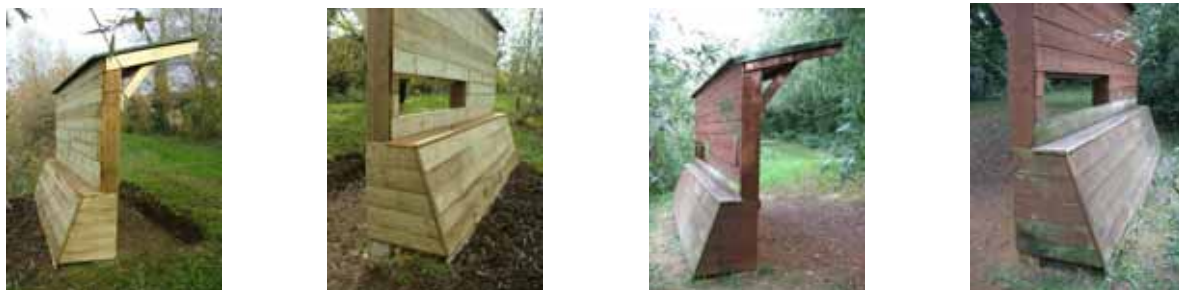
Bird Watching Hide: this is also still in good condition, showing little sign of misuse. As it was deliberately sited in a quiet corner of the site away from the main path, this lack of damage is not surprising. Its open-backed 'bus-shelter' form was designed to avoid previous problems of misuse in an enclosed hide, and this appears to have been successful.

Two views of the bird watching hide as built to the left and in its current condition (October 2007)

Hide and Seating: the natural oak bench seats should not require any maintenance, apart from scrubbing or power washing if surfaces eventually begin to accumulate excessive dirt or algal growth. The bird hide would benefit from a re-application of woodstain every two to three years.

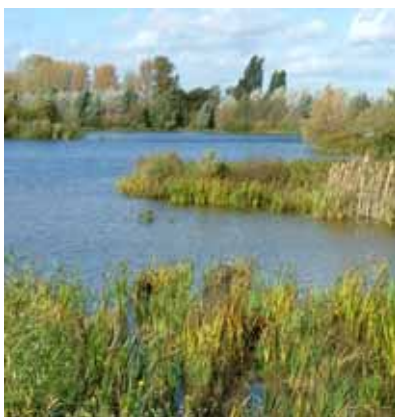
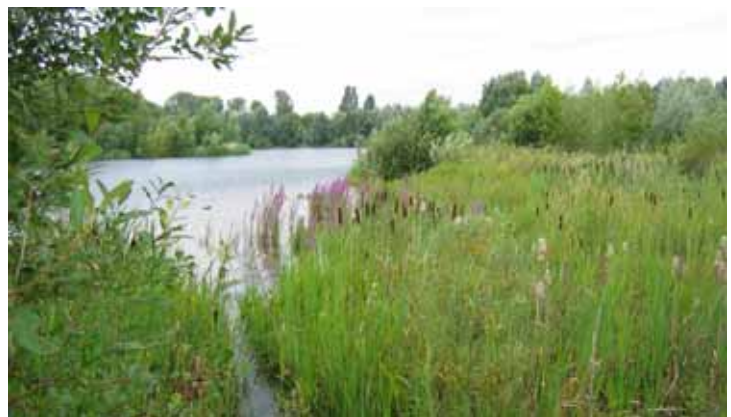
Aquatics: all the lakes contain aquatic plants of various kinds, from underwater oxygenating species to native water lilies. Such plants are transferred between water bodies by transient wildfowl, and are brought in by inflowing waters. Lammas Water has sufficient depth and surface area that colonising plants do not cause any problems. But the smaller water bodies now support considerable rafts of water lily leaves in summer, plus blanket weed, and some partial clearance may become necessary in the future in order to maintain open water. Reeds and Reedmace (Phragmites and Typha species) are also establishing along the shorelines of all the lakes, and a management decision to control their spread may be needed at

Two views of Lammas Water from similar viewpoints in 2004 to the left and 2007 to the right

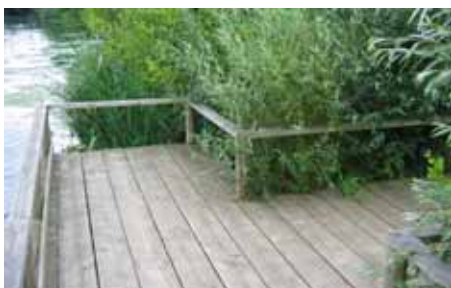
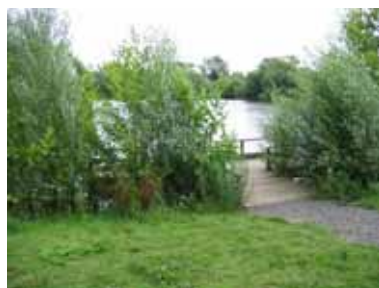
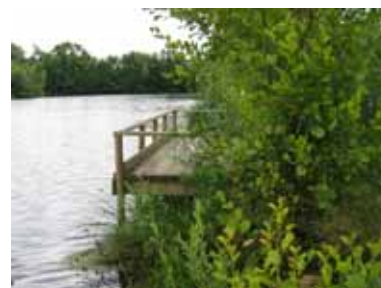
The fishing platforms at Hithermoor in Autumn 2007, two years after construction
